ASSESSMENT REPORT			
<b>Unique Document ID and Revision No:</b>	ONR-OFD-AR-18-051 Revision 0	<b>TRIM Ref:</b>	2018/348304
<b>Project:</b>	Torness Reactor 2 2018 Periodic Shutdown		
<b>Site:</b>	Torness		
<b>Title:</b>	Torness Reactor 2 2018 Periodic Shutdown: Structural Integrity Assessment of the Graphite Core Inspection Findings		
<b>Nuclear Site Licence No:</b>	Sc.14		
<b>Licence Condition(s):</b>	30		
<b>ONR Assessment Rating (Mandatory):</b> <i>(Rating should be based on licensee's original safety case submission)</i>	GREEN		
<b>COIN Service Order:</b>	SVC4285368

**Torness Reactor 2 2018 Periodic Shutdown – Assessment of the results of the  
Graphite Core Inspections**

Assessment Report ONR-OFD-AR-18-051  
Revision 0  
08 NOVEMBER 2018

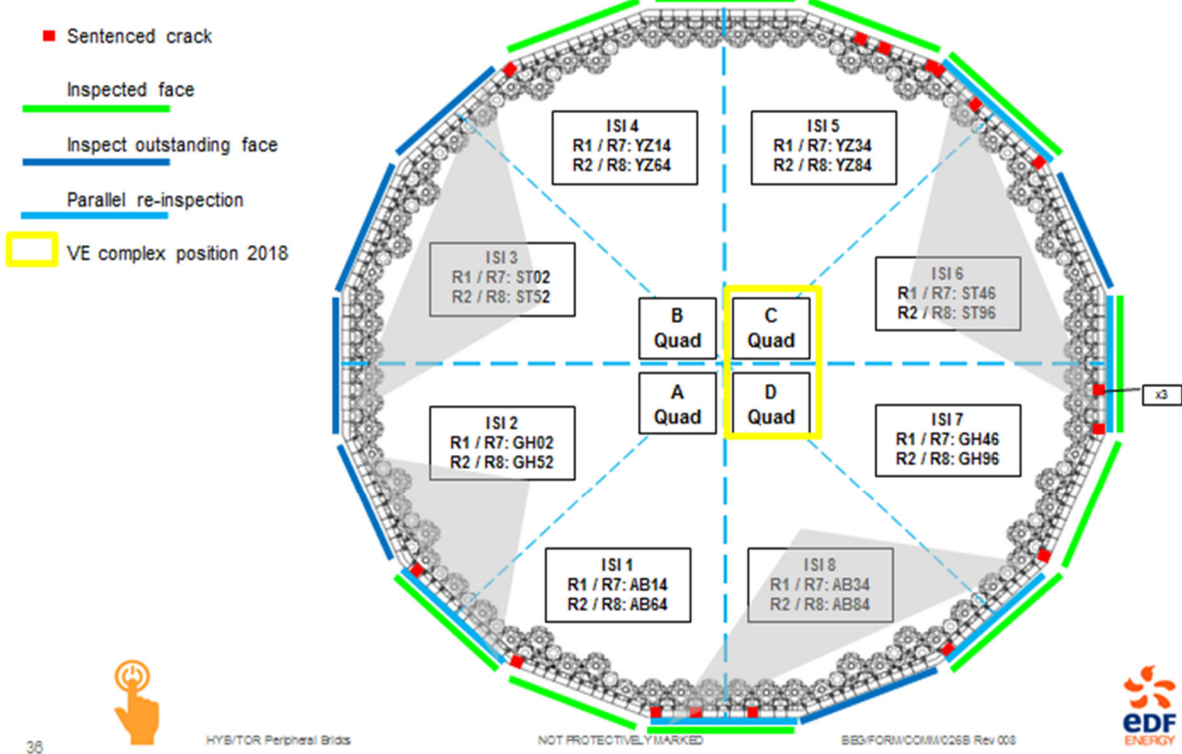
Figure 1: Peripheral brick inspections during the 2018 TOR R2 outage.

19. Remote visual inspections of the peripheral bricks were also performed using the Gas Baffle Inspection Manipulator (GBIM). During the outage, NGL inspected eleven out of sixteen faces of the peripheral walls, five of which had already been inspected in 2015; see Figure 1.

39. Eleven of the sixteen faces of the peripheral wall were inspected during the periodic shutdown, five of which were already inspected in 2015 (Figure 1). This corresponds to NGL’s inspection target prior to the periodic shutdown. I am therefore satisfied by this achievement. NGL produced Table 1 below summarising the findings of the peripheral brick inspections.

40. According to Table 1, 28 cracks in 26 cracked bricks were observed from the 11 faces inspected. This corresponds to ~2.0% of the overall number of peripheral bricks. The number of cracks therefore appears to be consistent with previous observations.
41. The face map shows that the defects appear to be overall uniformly distributed around the core of the reactor, with little evidence for clustering of defects (Reference 13).

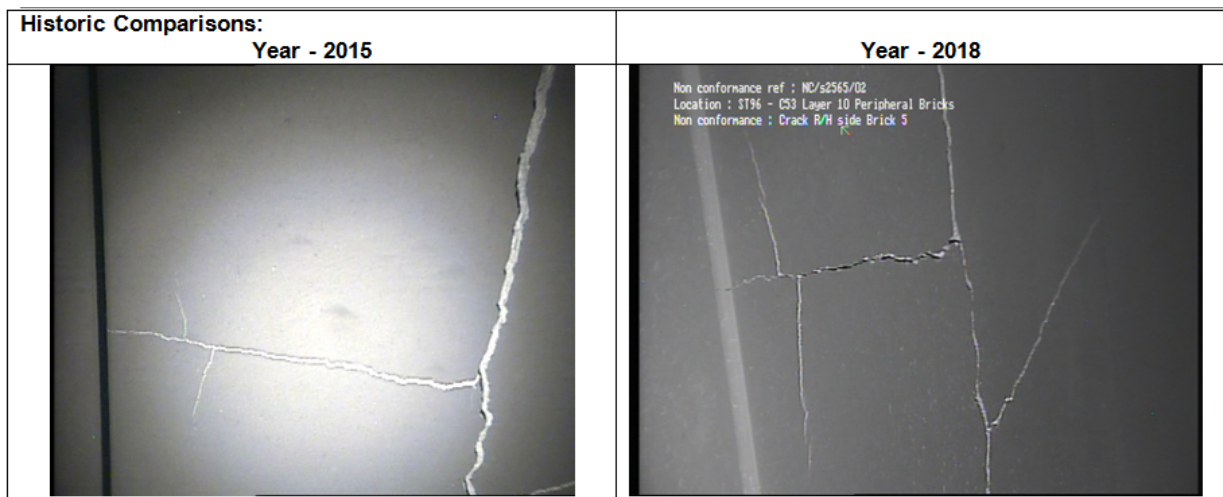
Figure 2: NCR S2565/02: Comparison between 2015 and 2018 inspections.

43. The cracks which were re-inspected during the periodic shutdown do not appear to have progressed, except the crack recorded in NCR S2565/02. In the latter case, progression appears to have been slow between 2015 and 2018, which is consistent with the safety case EC356536. I am therefore satisfied that the findings of the peripheral brick inspections appear to be consistent with EC356536.

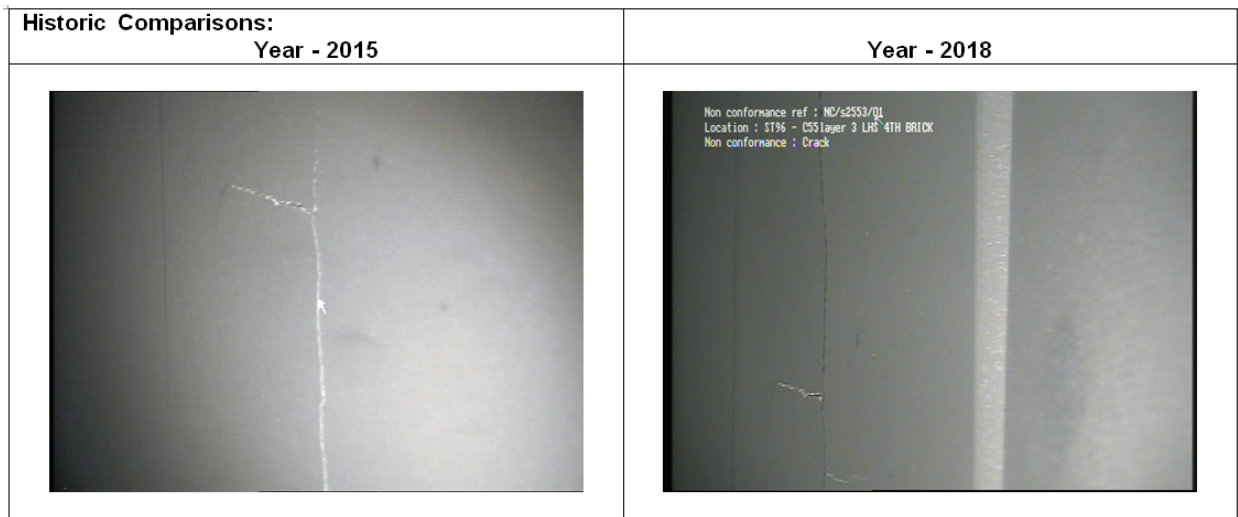
**Figure 3: NCR S2553/01: Comparison between 2015 and 2018 inspections.**

42. In my opinion, the morphology of the cracks appears to be consistent with the cracks previously seen in the other reactors at HYB and TOR. Inspection of the defects previously observed in 2015 showed that damage had progressed slightly since 2015 in some instances, e.g. NCR S2565/02 and NCR S2553/01 (Reference 13); see Figures 2 and 3. In Figure 3, a small branch, which was not visible in 2015, seems to be present in 2018. I informed NGL by e-mail that these cracks could be considered for future inspections in three years' time (Reference 17). NGL confirmed that the crack recorded in NCR S2553/01 was visible from the 2015 footage.
