ASSESSMENT REPORT			
Unique Document ID and Revision No:	ONR-OFD-AR-19-091 Revision 0	TRIM Ref:	2020/76467
Project:	Heysham 2 Reactor 8 2020 Periodic Shutdown		
Site:	Heysham 2		
Title:	Heysham 2 Reactor 8 2020 Periodic Shutdown: Structural Integrity Assessment of the Graphite Core Inspection Findings		
Nuclear Site Licence No:	588		
Licence Condition(s):	30, 28		
ONR Assessment Rating (Mandatory): <i>(Rating should be based on licensee's original safety case submission)</i>	GREEN		
COIN Service Order:	N/A

**Heysham 2 Reactor 8 2020 Periodic Shutdown – Structural Integrity Assessment of the
Graphite Core Inspection Findings**

Assessment Report ONR-OFD-AR-19-091
Revision 0
25th March 2020

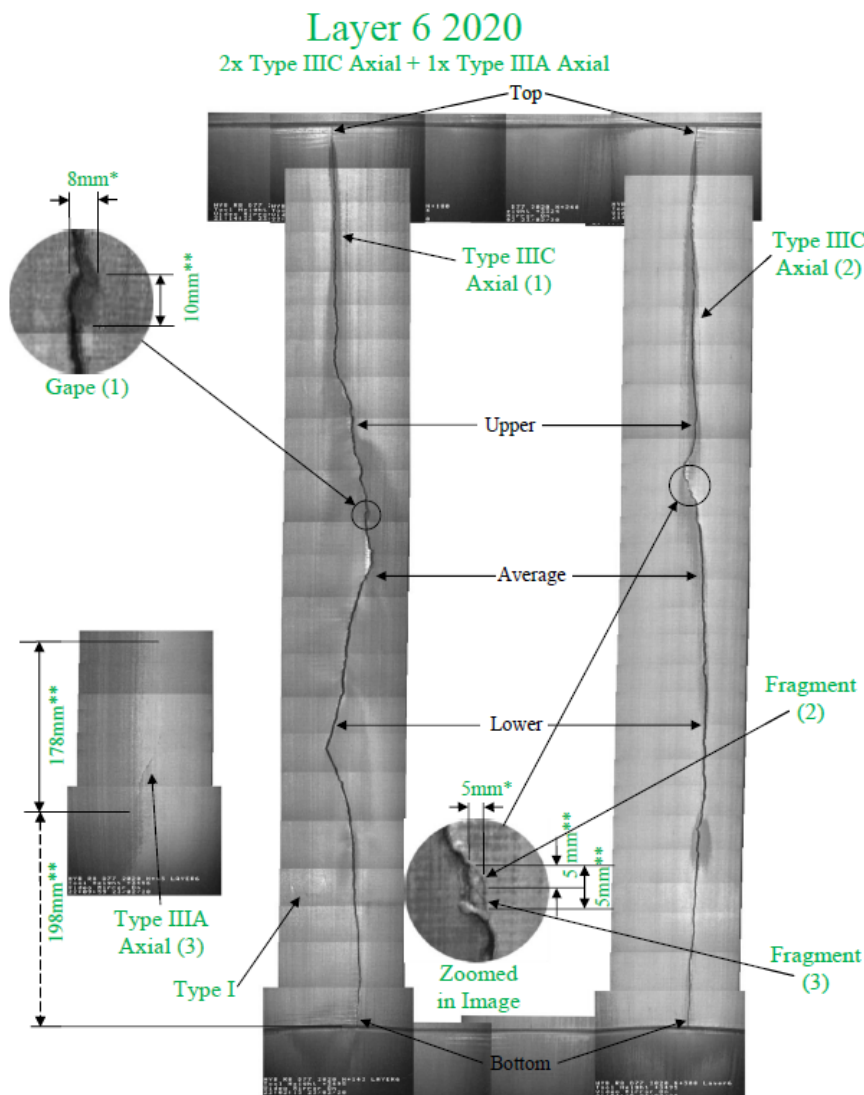
Figure 1: Doubly cracked brick with two full height axial cracks and one partial axial crack in Channel D77, Layer 6.

53. Two full height axial cracks and a third smaller axial crack were found in the channel D77 Layer 6 brick; see Figure 1. This was the first inspection of the channel since first commissioning of the plant.

54. I observed the GAP meeting which had been specifically convened to discuss the findings from this channel (Reference 2). Following the review of the inspection data, the GAP members concluded that the morphology of the cracks and the measurements taken from the bore were evidence that the cracks have initiated from the bore (see 5th GAP minutes in Reference 17).

57. In my view, the morphology and the tortuosity of the cracks are consistent with bore-initiated cracking. 'Lipping in', characteristic of bore cracking, is also evident from the measurements, as shown in Figure 2. I therefore agree with the conclusions from the GAP that the cracks are likely to have initiated from the channel bore earlier in the life of the reactor.

59. In my opinion, the smaller partial height crack visible in Figure 1 is unlikely to grow to a significant extent by the same damage mechanism as bore cracking is considered to be an early life damage mechanism.

60. The bore measurements from channel D77 were within expectation and do not show any sign of significant displacement due to the presence of the cracked brick in layer 6. Although the GAP assessors highlighted 3 fragments in Figure 1, I do not consider that these would be significant if these were to become detached.

62. However, the PAR should note that a doubly cracked brick was observed in channel D77 layer 6. NGL should consider whether this channel should be re-inspected in future fuel channel inspections (Recommendation 3).

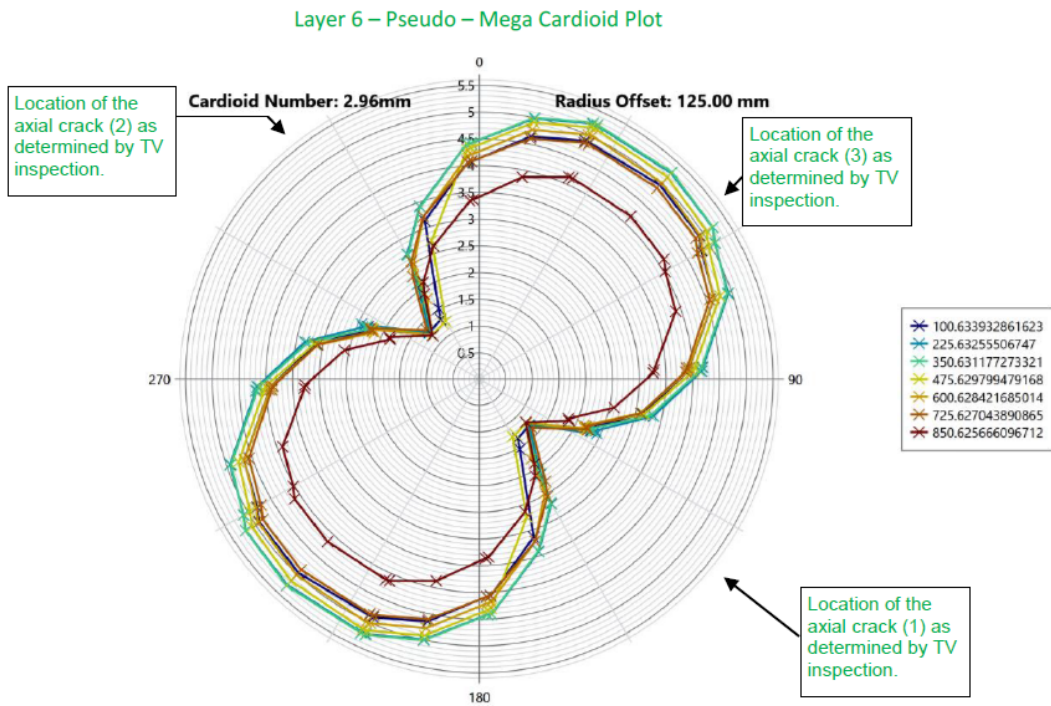
Figure 2: Bore measurements of fuel brick in channel D77, layer 6.

61. Overall, the graphite inspection findings were broadly within expectation. The bore measurements show that the channel distortions remain small and do not challenge the safety case assumptions. In my view, the number of cracked bricks in the core is below the level of cracked bricks that could challenge the safety case. I am content that the presence of the doubly cracked brick in channel D77 does not undermine this conclusion. The findings of the fuel channel inspections are therefore acceptable.

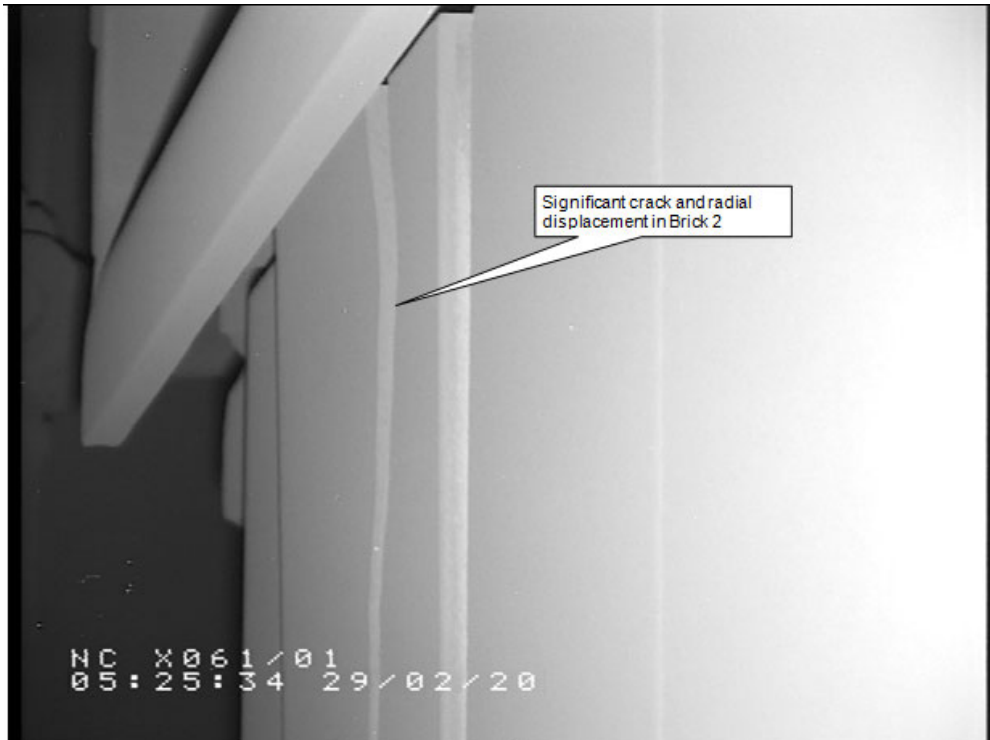
71. During the inspections, Face 15, Layer 4, Brick No. 2 was found to be cracked at the top of the brick. However, the crack does not appear to extend the full height of the brick; see Figures 3 and 4. This face had not been inspected before.

Figure 3: Cracked brick in Layer 4 of Face 15, Brick No. 2 (top of the brick).

72. Reviewing the result of this inspection, the PBAP noted that:
- the crack has significant separation particularly at the top of the brick;

- the adjacent bricks do not appear to be cracked or displaced.
73. The PBAP considered the significance of this defect with respect to the safety case. The following aspects were considered: the stability of the brick, the thermal consequences of a missing brick and debris. NGL noted that no missing bricks had been observed and that it was unlikely that any brick section had become dislodged. NGL concluded that the consequences with regard to re-entrant flow remain and debris would remain acceptable and are covered by the existing safety case (Reference 3).

74. In my view, the gapping would not be sufficient to cause a significant bypass of the coolant flow. Similar 'leaning' bricks have been found previously in the TOR reactors. The consequences of cracking are therefore considered in the existing safety case (Reference 3). In my opinion, the PBAP's judgement with regard to this brick seems appropriate. I am therefore of the view that NGL's conclusions are acceptable.

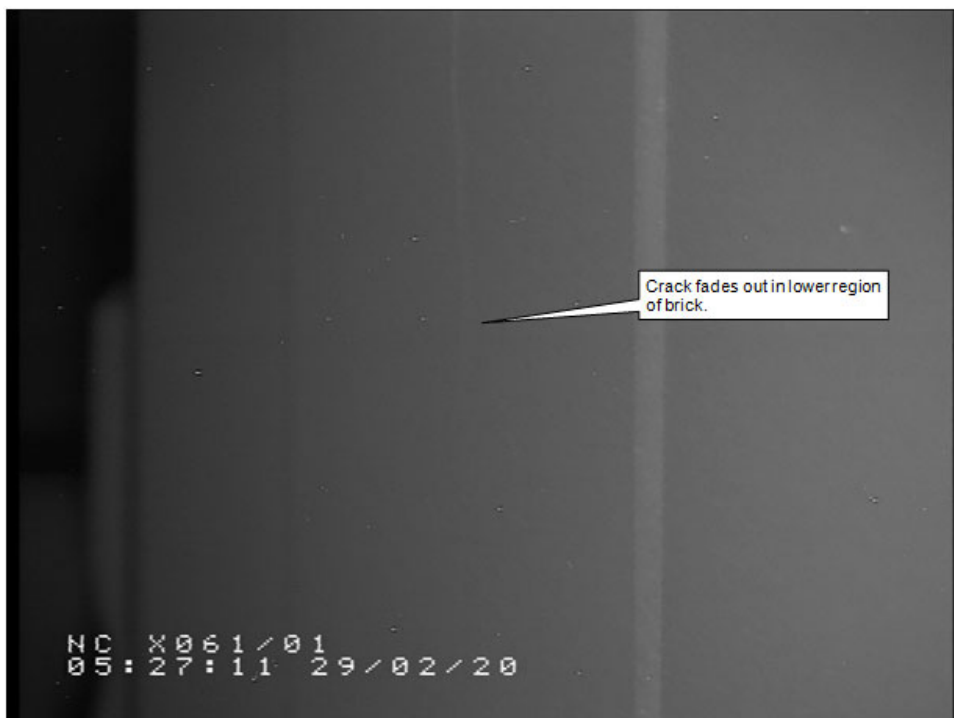
Figure 4: Cracked brick in Layer 4 of Face 15, Brick No. 2 (bottom of the brick).
