ASSESSMENT REPORT			
Unique Document ID and Revision No:	ONR-OFD-AR-17-009 Revision 0	TRIM Ref:	2017/189621
Project:	Torness (TOR) Reactor 1 (R1) 2017 Periodic Shutdown		
Site:	Torness		
Title:	Torness (TOR) Reactor 1 (R1) 2017 Periodic Shutdown – Assessment of the results of the Graphite Core Inspections		
Nuclear Site Licence No:	Sc14		
Licence Condition(s):	30, 28		
ONR Assessment Rating (Mandatory): <i>(Rating should be based on licensee's original safety case submission)</i>	Green		
COIN Service Order:

**Torness Reactor 1 2017 Periodic Shutdown – Assessment of the results of the Graphite
Core Inspections**

Assessment Report ONR-OFD-AR-17-009
Revision 0
24 May 2017

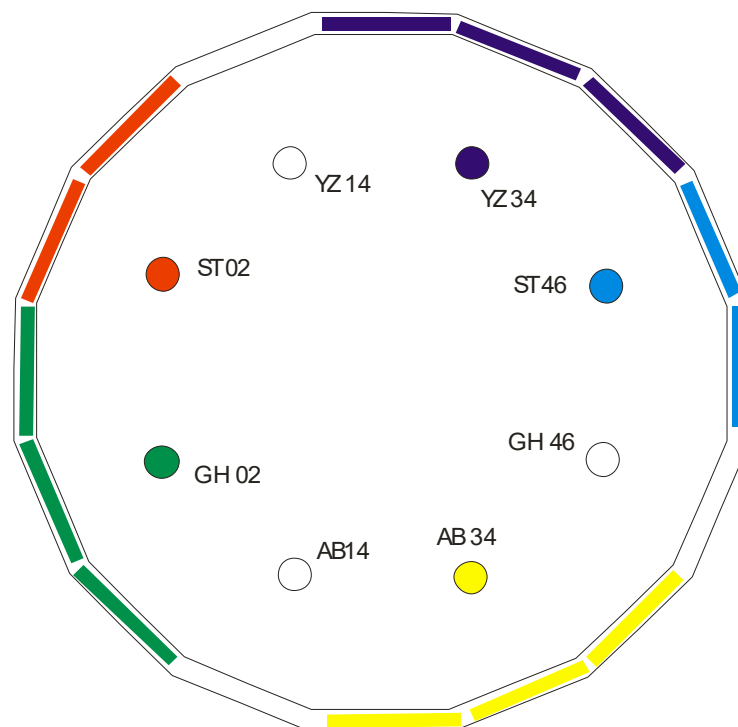
12. Inspection of 13 out of 16 faces, see Figure 1, of the peripheral shield wall at TOR R1 found 25 cracked bricks which extrapolates to a total of 31 cracked bricks for the entire peripheral shield wall, approximate to 1.6% cracked bricks, if the incidence of cracking is uniformly distributed.

Figure 1: TOR R1 2017 Peripheral Inspection Coverage.

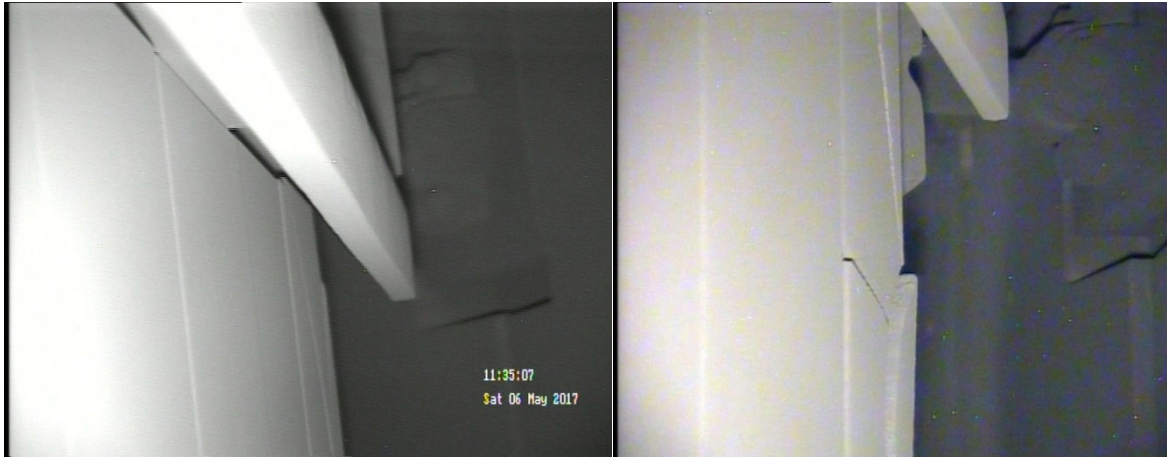
13. Overall, NGL claims that the observed cracking is broadly consistent with that seen in TOR R2 2015 and HYB R8 2016 where approximately 1.5% and 2.1%, respectively, of peripheral shield wall bricks were determined to have cracked. However, when examining closely the morphology of the cracks, it is evident that the TOR R1 findings show more similarity to HYB R8 than to TOR R2.
14. Out of the 25 cracks found in TOR R1, only three are pronounced cracks found in the corner bricks which exhibit certain level of similarity to TOR R2, albeit not as severe, see Figures 2, 3 and 4. Other cracks however, are fairly tight, straight and mostly located in the mid-face of the brick (see Figure 5), which bears close similarity to the HYB R8 2016 findings.

Figure 2: Left: Branched Crack in a Corner Peripheral Brick in **TOR R1**; found via route C50, penetration YZ34. Right: Significant Branched Crack found in a Corner Peripheral Brick in **TOR R2** 2015.

37. I have observed that the cracks found in TOR R1 bear close similarity to those in HYB R8, and some, although not as severe, exhibit resemblance to the branched cracks in TOR R2. However, most importantly, I consider that the percentage of cracking of 1.6% demonstrate consistency with the 1.5% cracked bricks found in TOR R2 2015 and 2.1% in HYB R8 2016.

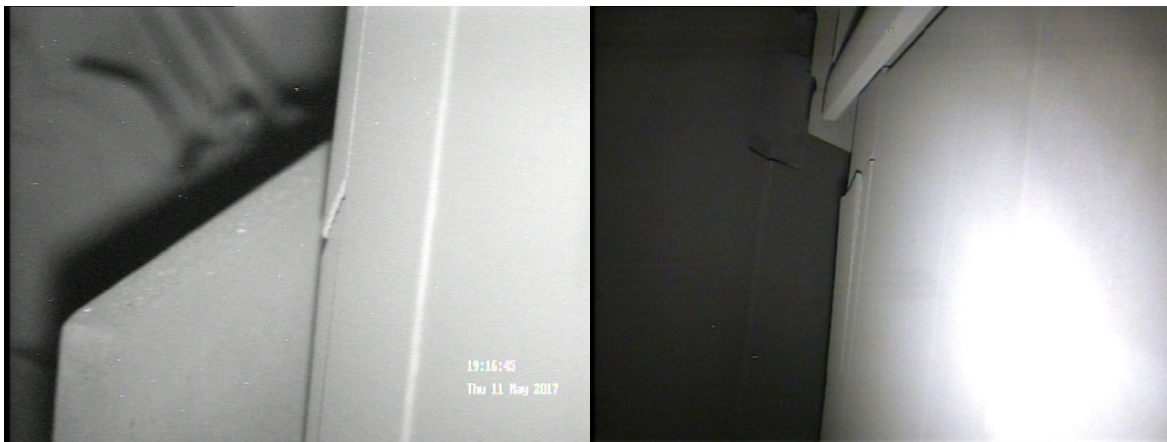
Figure 3: Left: Pronounced Crack in a Corner Peripheral Brick in **TOR R1**; found via route B51, penetration ST02. Right: Significant Branched Crack found in a Corner Peripheral Brick in **TOR R2** 2015

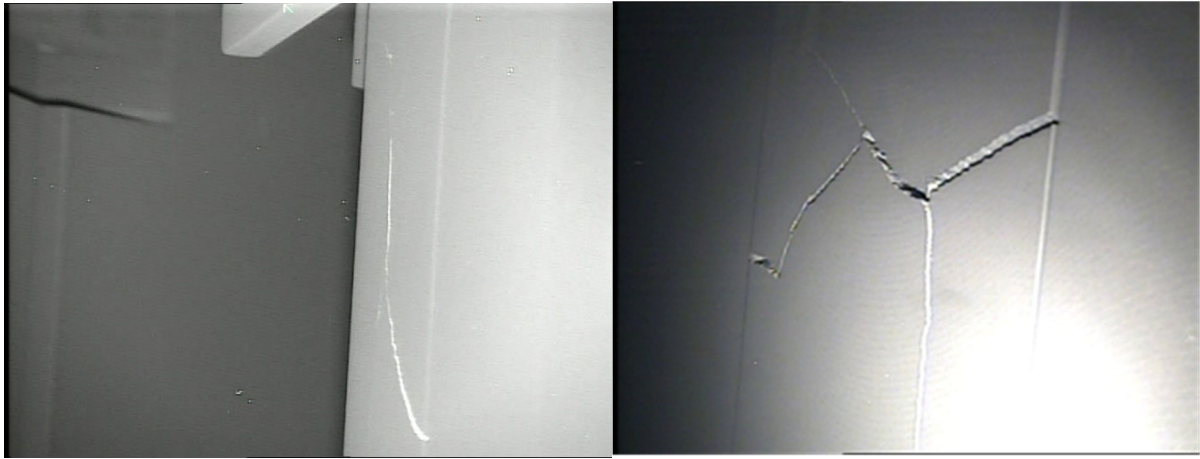
Figure 4: Left: Branched Crack in a Corner Peripheral Brick in **TOR R1**; found via route D55, penetration AB34. Right: Chicken-Wire Crack found in **TOR R2** 2015

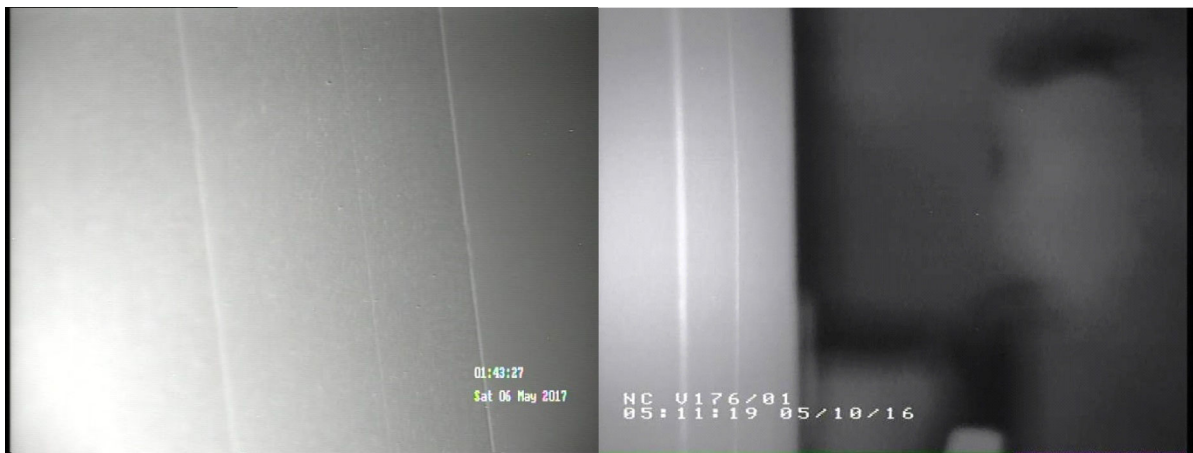
Figure 5: Left: Linear Crack Observed in **TOR R1**; Right: Linear Crack Observed in **HYB R8** 2016.

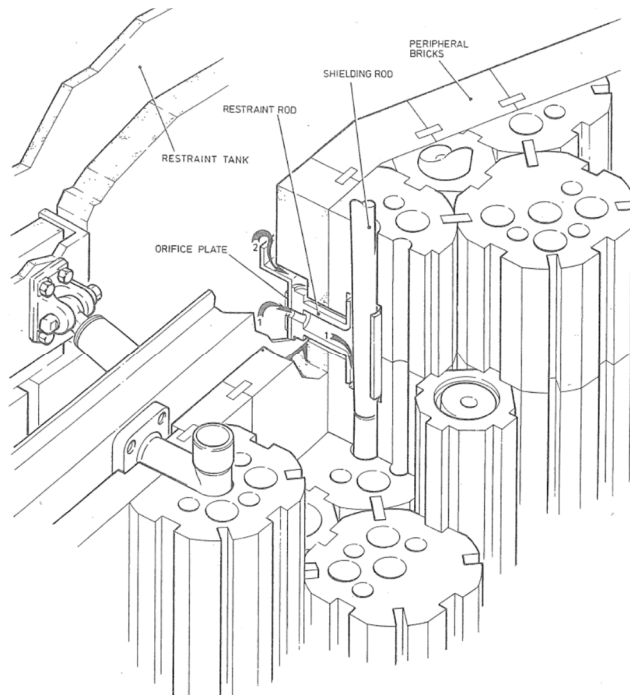
17. The core restraint arrangement is shown in Figure 6. Steel restraint rods pass through the peripheral shielding bricks at each interlayer position. Short steel cylinders, or inserts, are mounted on the ends of the restraint rods and locate in selected graphite outer reflector bricks. The restraint rods attach to restraint beams forming a sixteen-sided polygon around the core at each interlayer. The beams are loosely connected at their ends by pin joints, as a secondary restraint feature, and their weight is supported through pads which rest on cut-outs in the peripheral shielding bricks. Radial loads from the core are transferred to the restraint tank by two ball-ended restraint links – Warwick links. These constrain the core boundary to move radially with the steelwork, whilst at the same time allowing for differential thermal expansion of the graphite core structure and the steel restraint tank in the vertical direction.

Figure 6: Restraint Structure showing Peripheral shielding bricks and Gas Coolant Flow

18. NGL's core restraint inspection was conducted at the same time as the peripheral brick inspection, as the camera was inserted in the annulus between the restraint tank and the peripheral shield wall. During the television inspection, views were obtained of the peripheral shielding graphite bricks, horizontal restraint beams, Warwick links and the joints connecting the restraint beams and the restraint tank wall. NGL reported that no significant degradation or deformation was observed in the core restraint components.

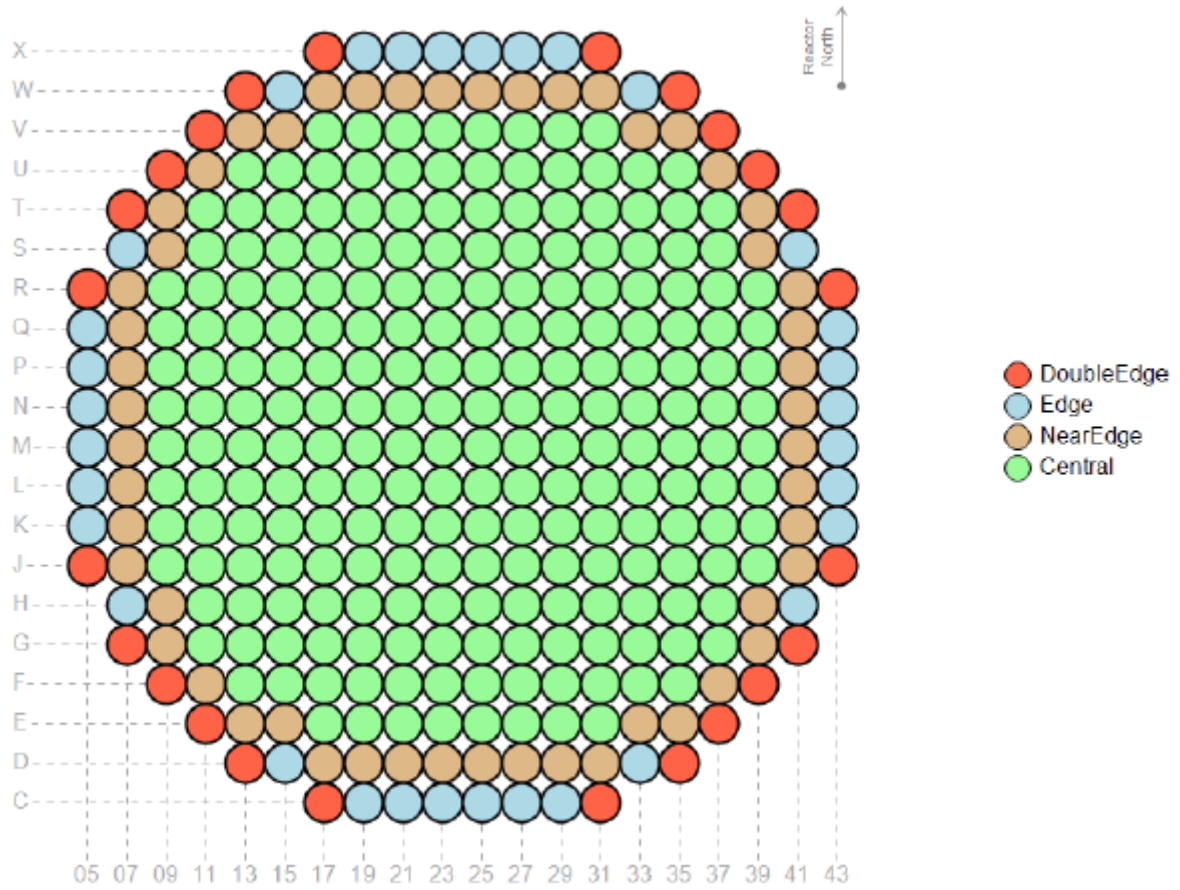
28. Subsequent inspection of the adjacent channel G11, see Figure 7, revealed no cracking in any of the bricks; the channel bow and tilt were 1 mm and 5 mm, respectively, but were all within the acceptance limits and did not suggest significant distortion.

Figure 7: TOR R1 core map

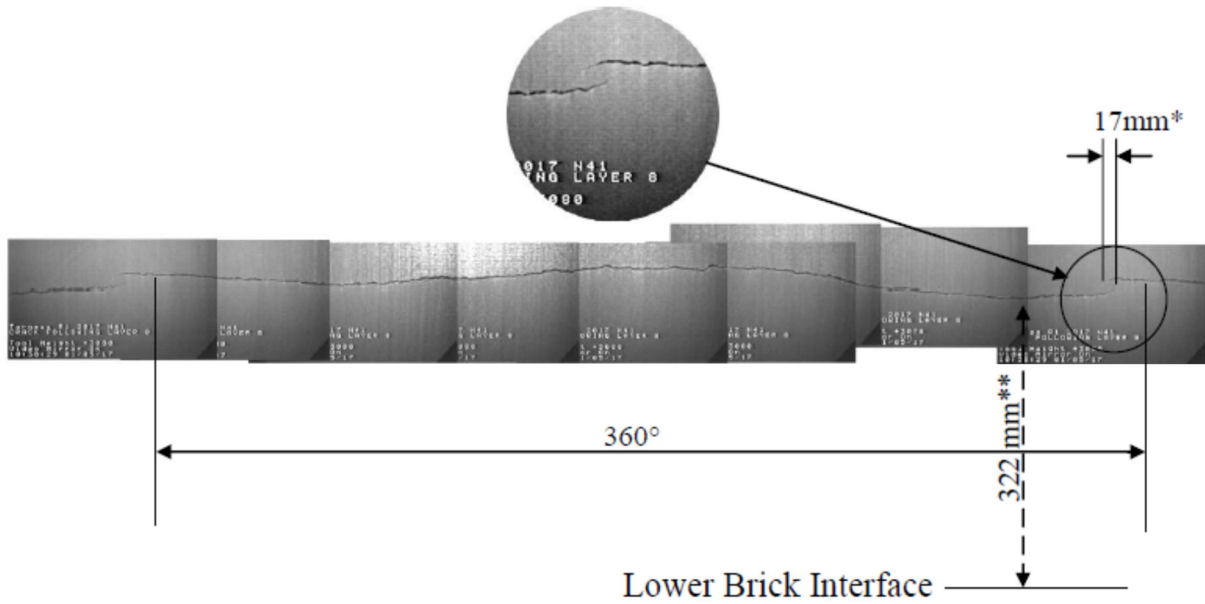
31. NGL reported that one fully circumferential crack (Type IIIC) was observed in Layer 8 of Channel N41 (Figure 8), which had not been previously inspected. One partial circumferential crack in Layer 5 of Channel C31 had grown to a fully circumferential crack between 2010 and 2017 (Figure 9). All bore shrinkages and channel distortions were however small and within expectations set by NGL [14].

Layer 8 2017

Type IIIC Circumferential (1)

Figure 8: Fully circumferential crack found in a layer 8 brick of fuel channel N41 in TOR R1

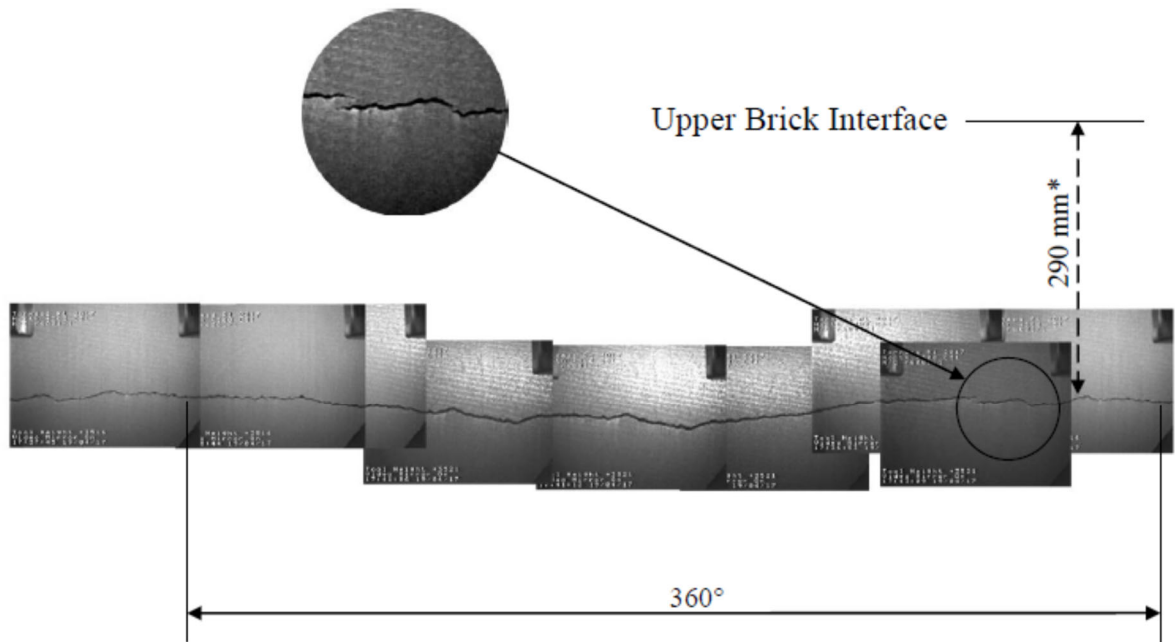
Layer 5 2017

Type IIIC Circumferential (1)

Figure 9: Partial circumferential crack found in layer 5 brick of fuel channel C31 grown to a fully circumferential crack between 2010 and 2017
